WHAT IS BRAKE JUDDER?

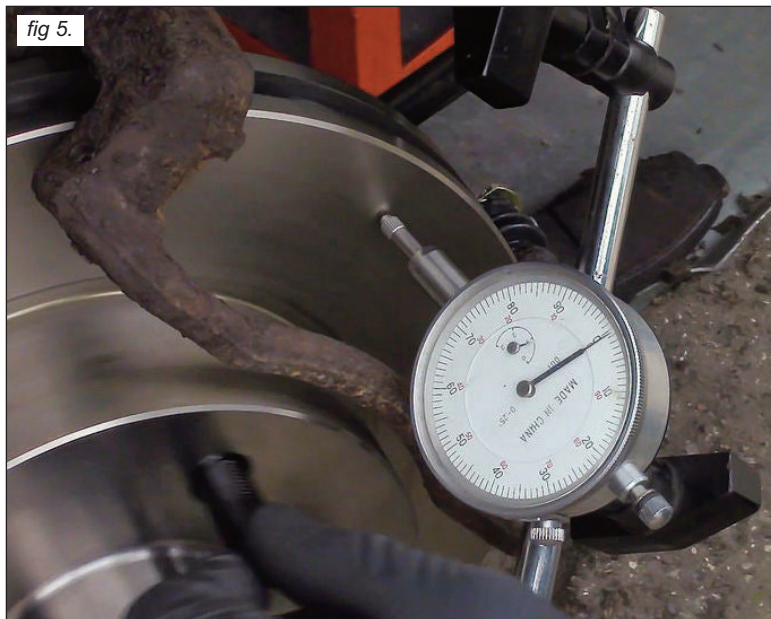
fig 5.

1. Clean the hub of rust or debris.
2. Then check the hub for run-out using a dial gauge.
3. Install the new disc and then check using a dial gauge (see fig 5) mounted close to the outer radius of the disc; the installed value of radial run out should not be greater than 70 microns.
